Manhole Inspection Summary

Manhole # S33C__014MH

Insp Date: **8/27/09 9:28 AM**

Location Address: **219 W MULBERRY ST**

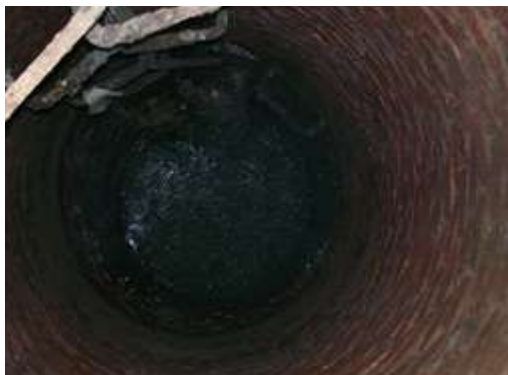
Defect 1

Count: **12** Missing: **0** ☒ **Corroded**

corroded steps

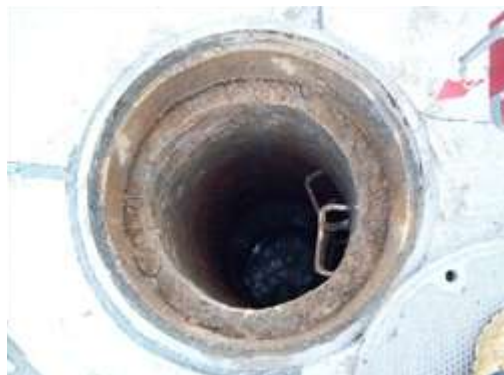
Defect 4

Offset: **1** (in.)

FRAME OFFSET

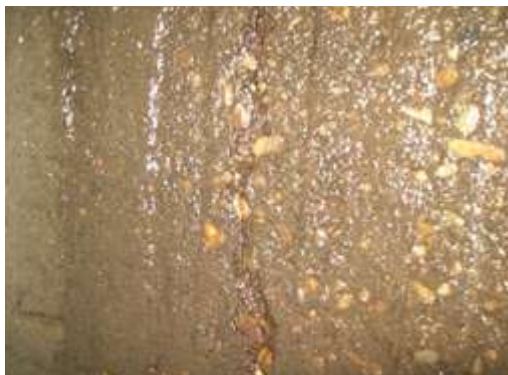
Defect 3

Condition: ☐ Sound ☒ **Cracked** ☐ Root Intrusion ☐ Loose Brick ☐ Deteriorated

Infiltration: ☐ None ☒ **Joint** ☒ **Cracks** ☒ **Mortar** ☐ Roots ☐ Wall

CRACK IN BARREL, INFILTRATION AT JOINT, CRACKS AND MORTAR

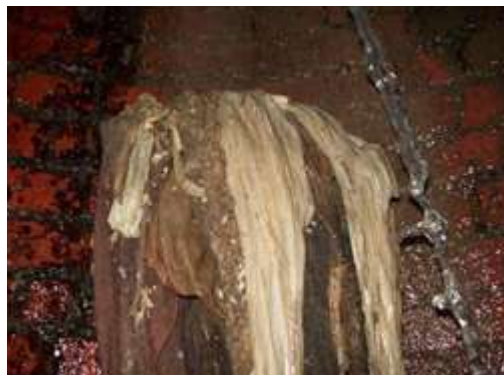
Defect 4

☒ **Evidence Of Surcharge** Depth: **13** (ft.) ☐ Active Surcharge Present

EVIDENCE OF SURCHARGE

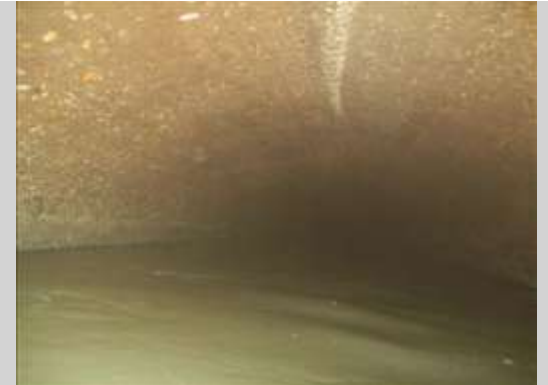
12 O'Clock Outflow

72 in. Circular Gravity Sewer
Pipe Out @ 12 O'Clock

Deposits: ☐ None ☒ **Mud** ☐ Sludge ☒ **Debris** ☐ Grease

Silt Depth: **19** (in.) Deposits Extent: **Medium**

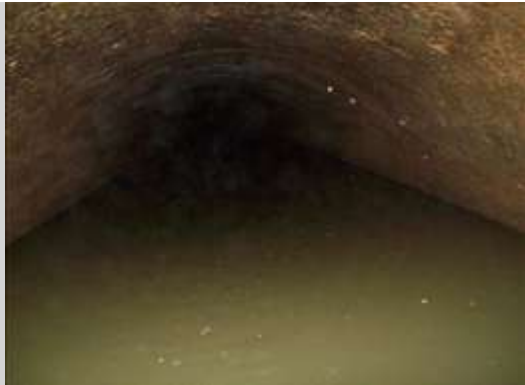
6 O'Clock Inflow

Deposits: ☐ None ☒ **Mud** ☐ **Sludge** ☒ **Debris** ☐ Grease

Silt Depth: **19** (in.) Deposits Extent: **Medium**

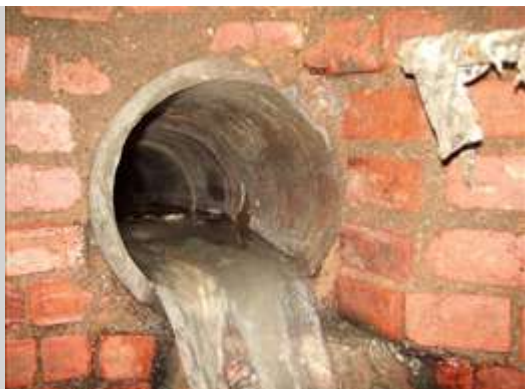
9 O'Clock Inflow

Deposits: ☐ None ☐ Mud ☒ **Sludge** ☒ **Debris** ☐ Grease

Silt Depth: **2** (in.) Deposits Extent: **Medium**
